*California Department of Transportation
Division of Maintenance*

Structure Maintenance and Investigations

Bridge Number : 10 0136
Facility Carried: STATE ROUTE 1
Location : 01-MEN-001-43.74
City :
Inspection Date : 10/06/2015

STRUCTURE NAME: ALBION RIVER

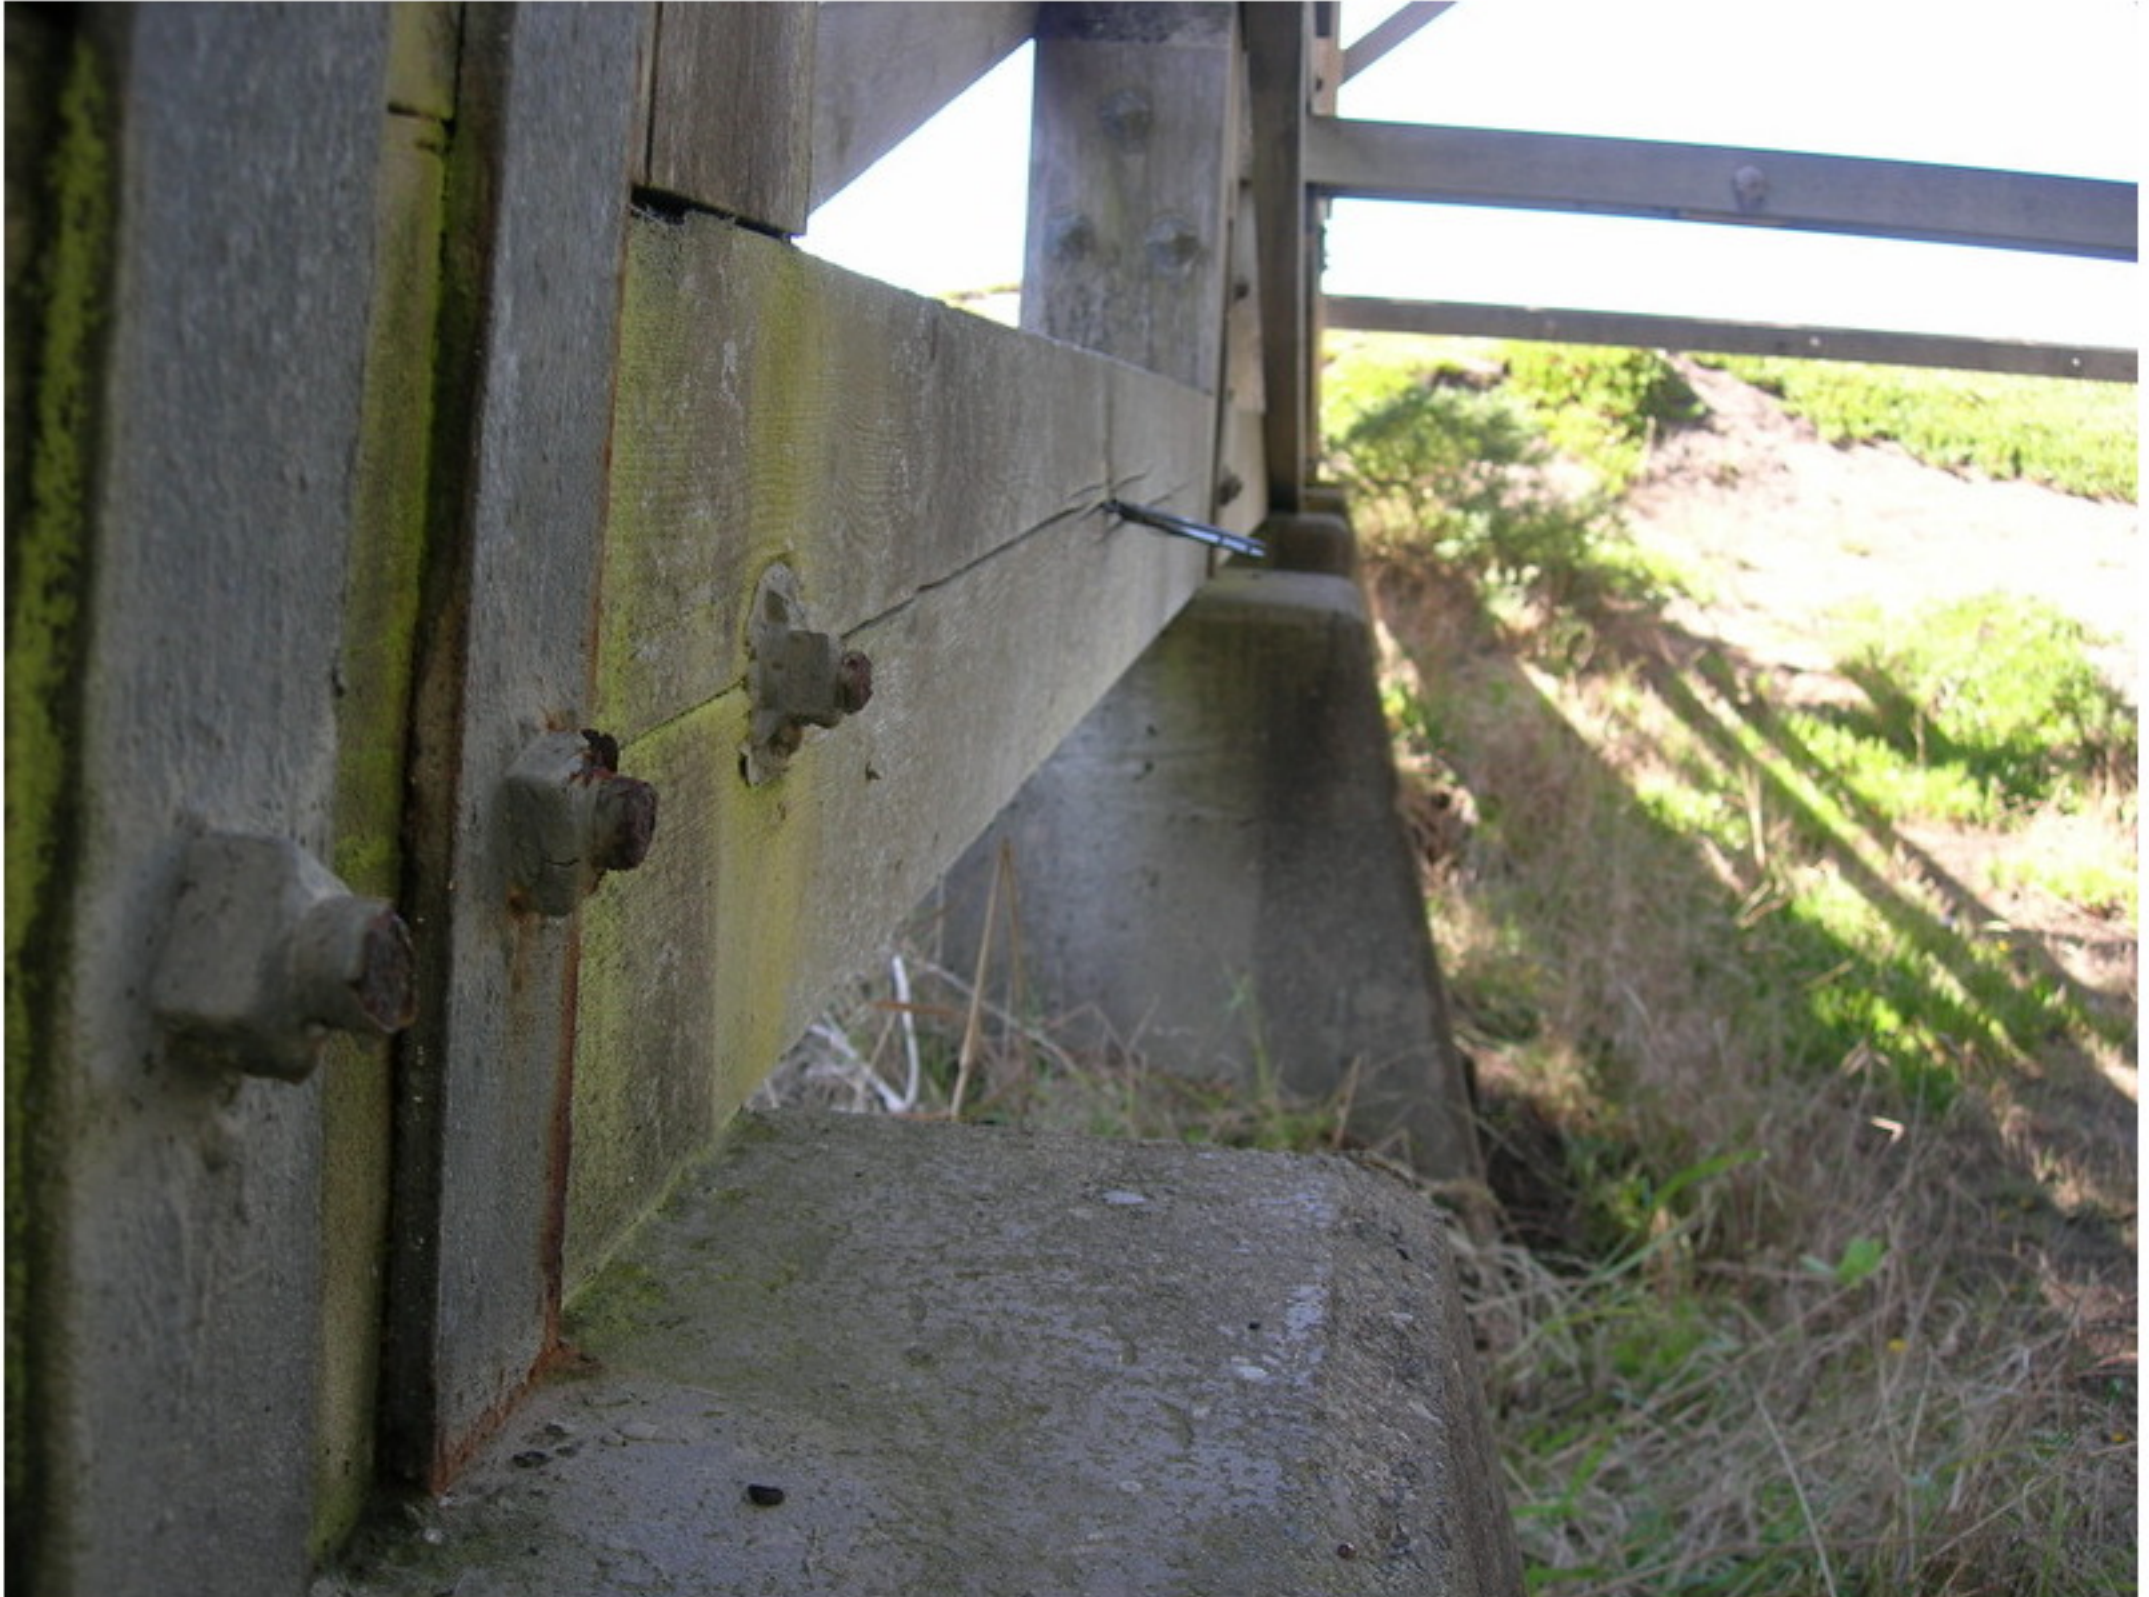
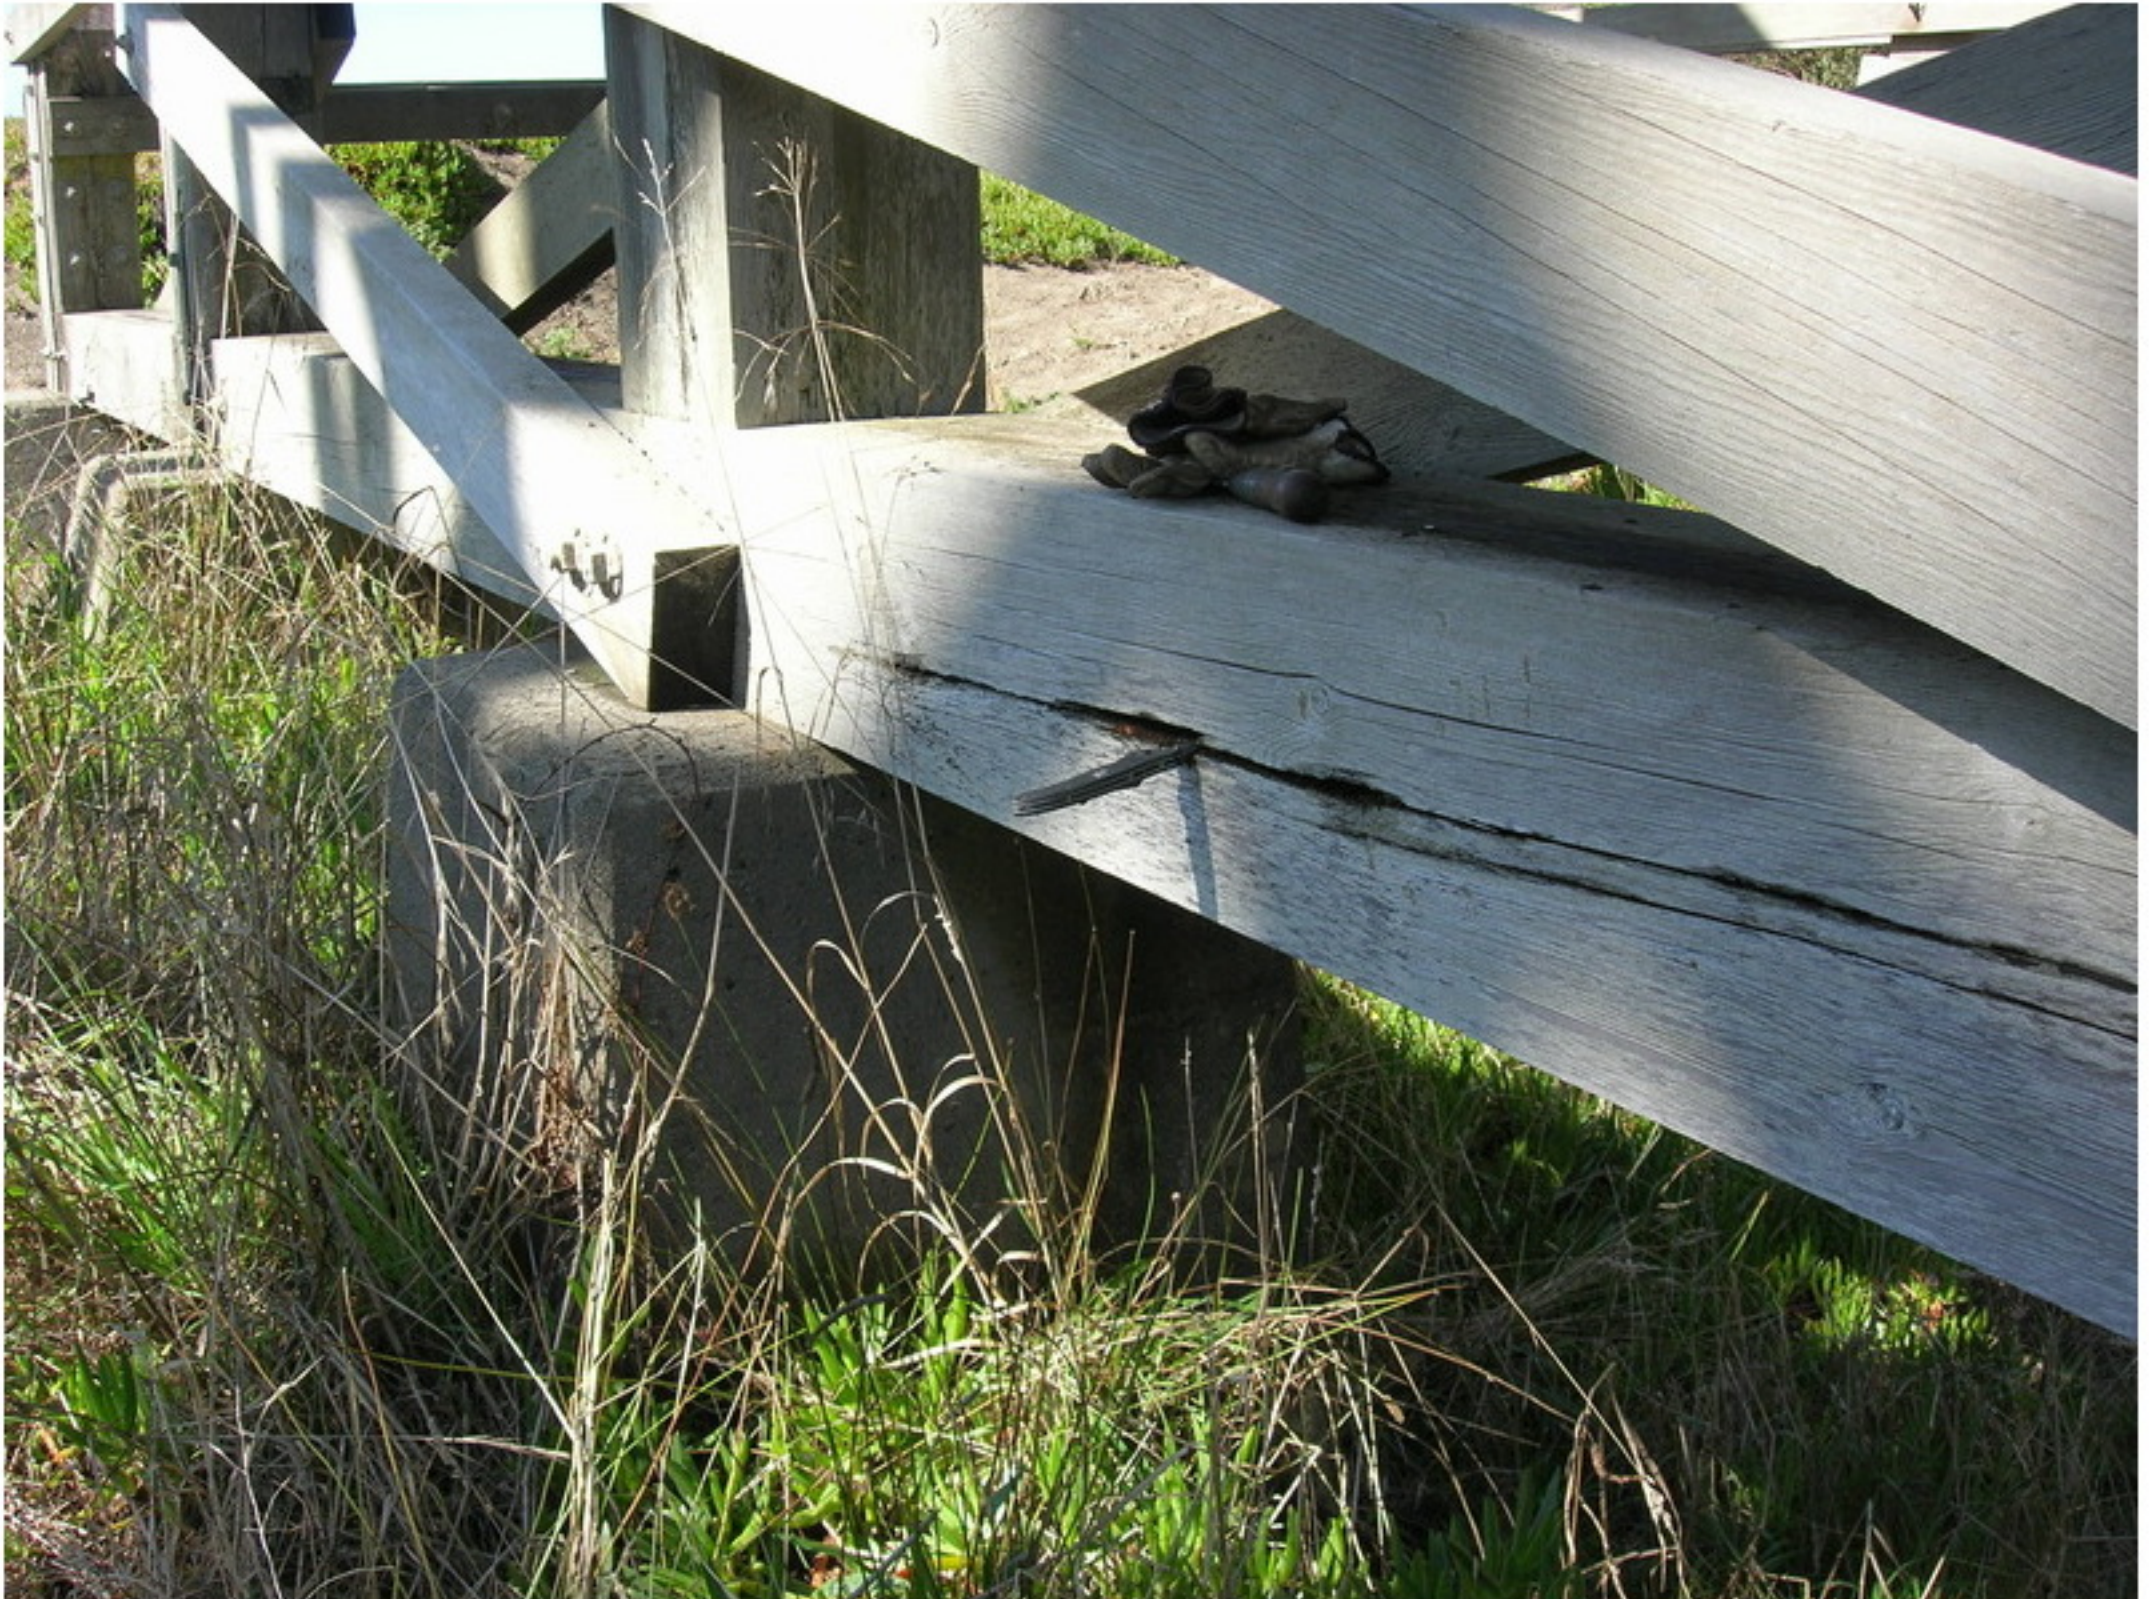
The horizontal transverse beam at the base of the legs of Bent 27 has 0.16 to 0.32 inch wide cracks in its sides between Post/Leg 3 and Post/Leg 4. The wood around the cracks/splits is damp and the interior appears to be soft when poked with a knife or awl. The member was drilled with an auger bit and found to be decayed in the core. The condition was only present in the area between the vertical members. When the beam was drilled under the posts no decay was found.

Photo No. 17
Looking west at the base of Bent 27 - Note spalls in side of the horizontal member

Looking west at the base of Bent 27 - Note damp splits in side of the horizontal member

Repair (remove and replace and/or supplement) all portions of the horizontal transverse beam at the base of the legs of Bent 27 & 29 where the wood is decayed in the interior. Portions of the members were drilled with an auger bit and found to be decayed in the core.

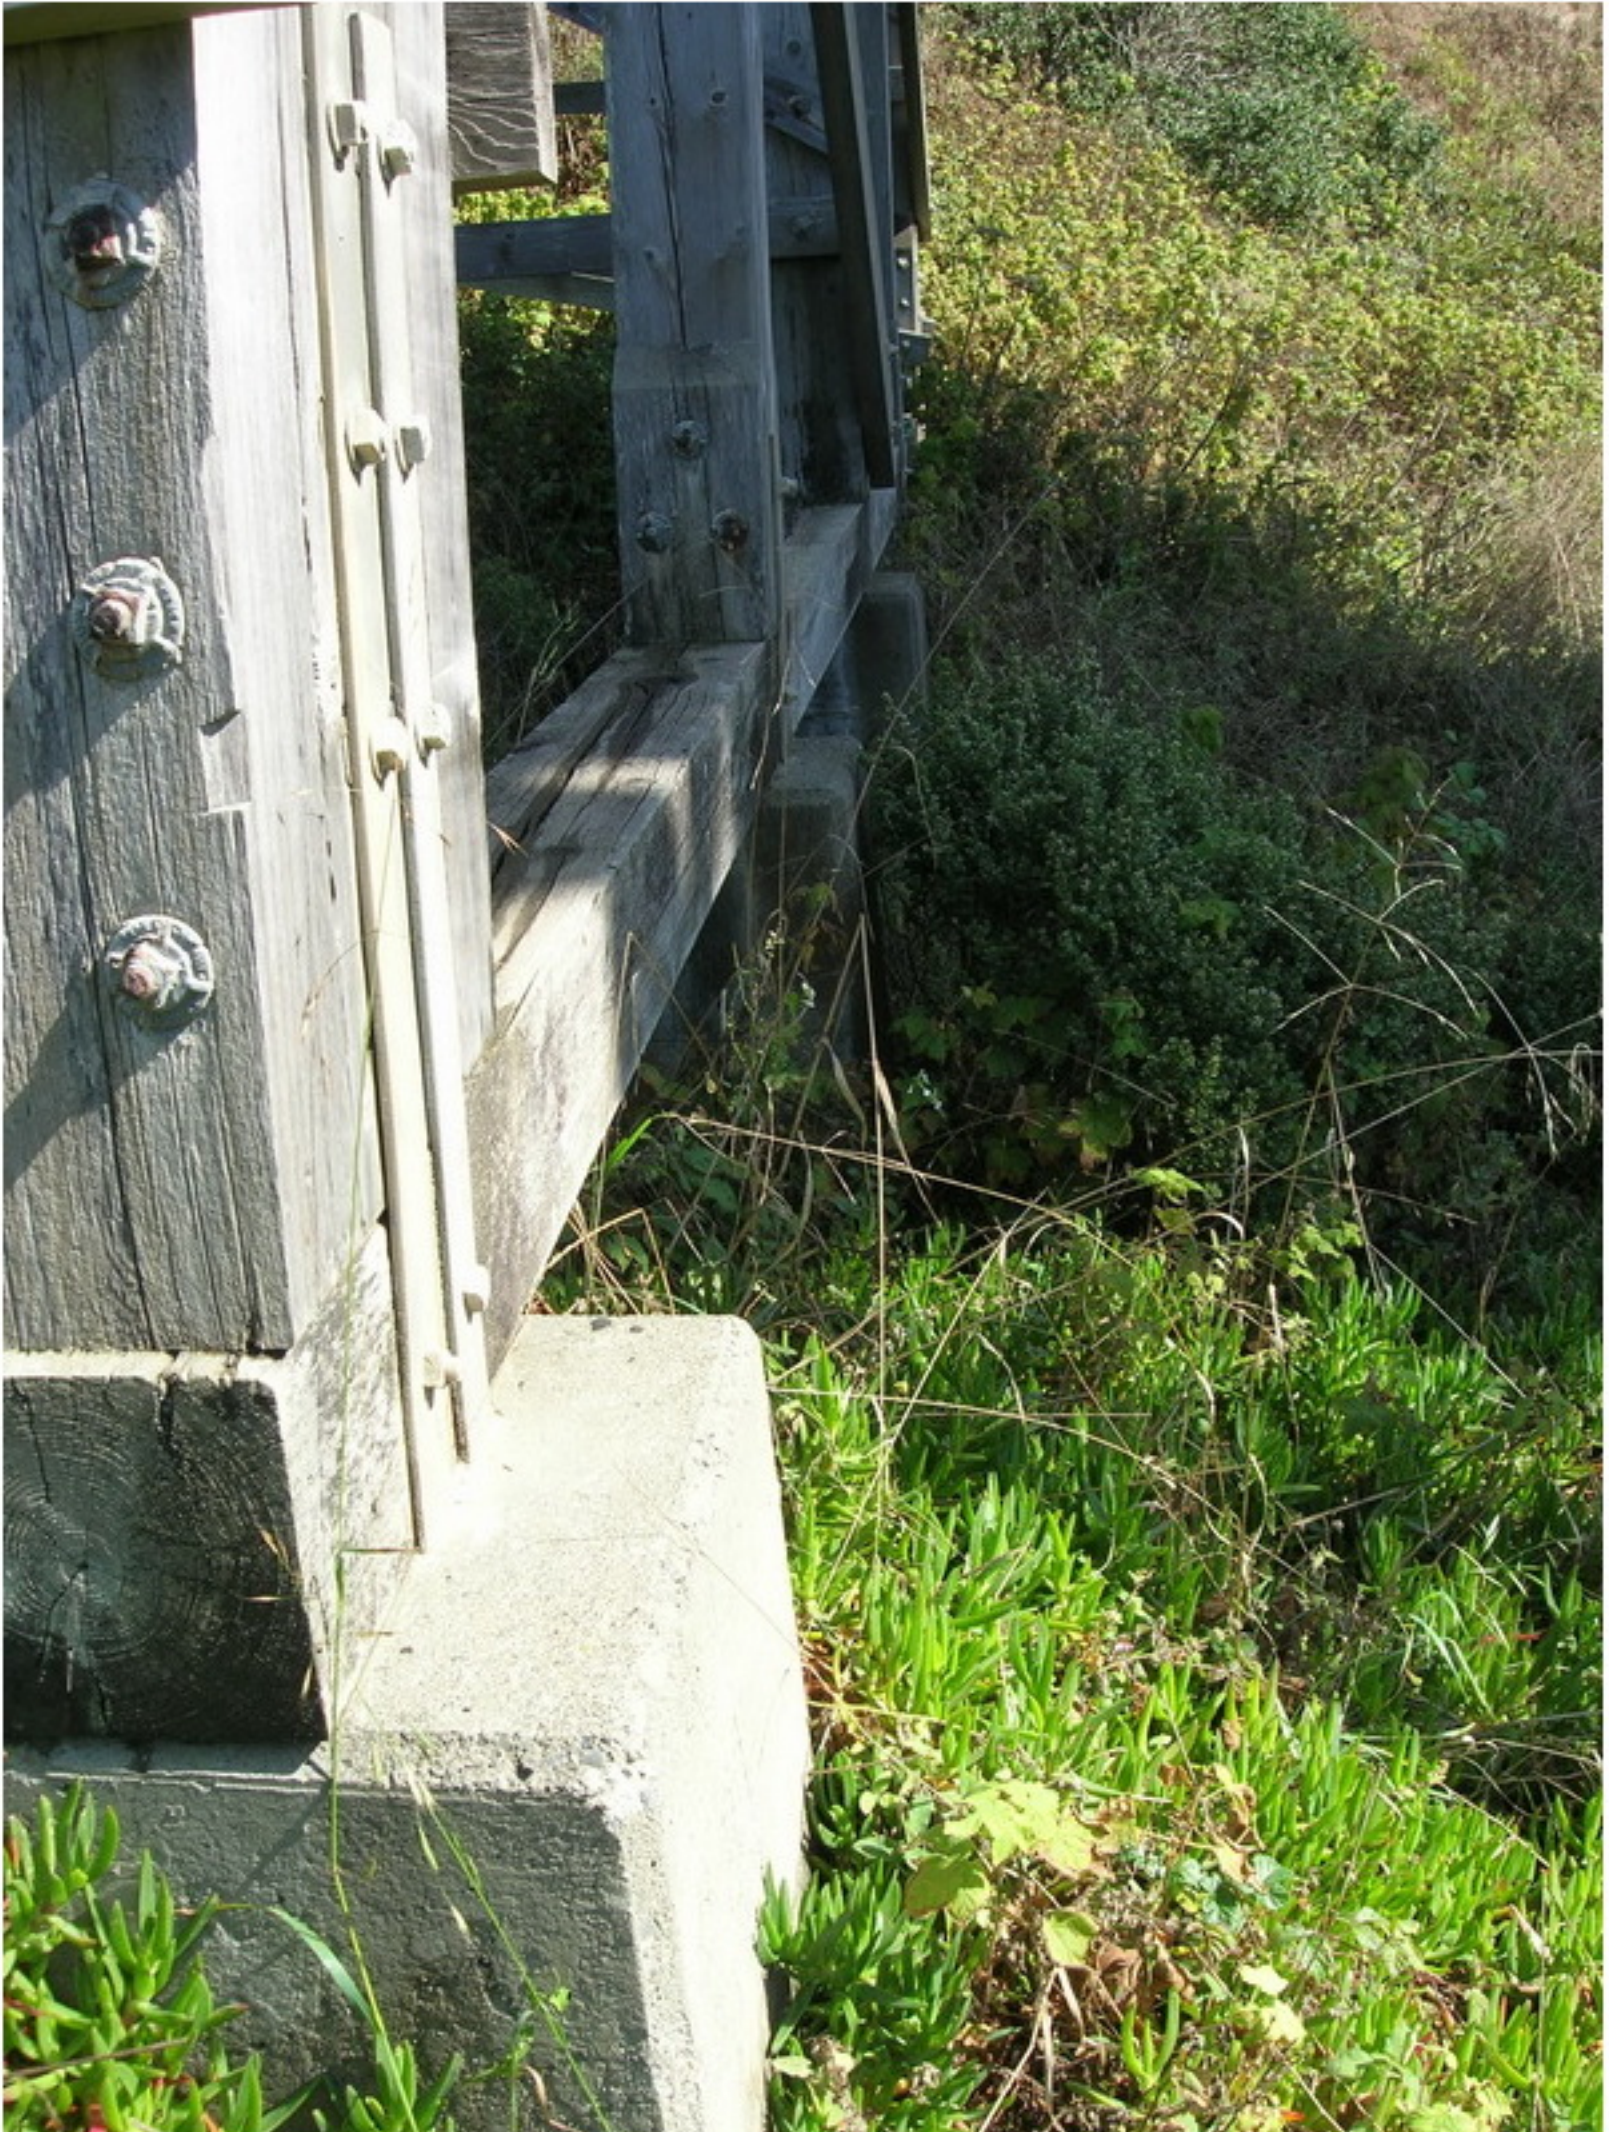
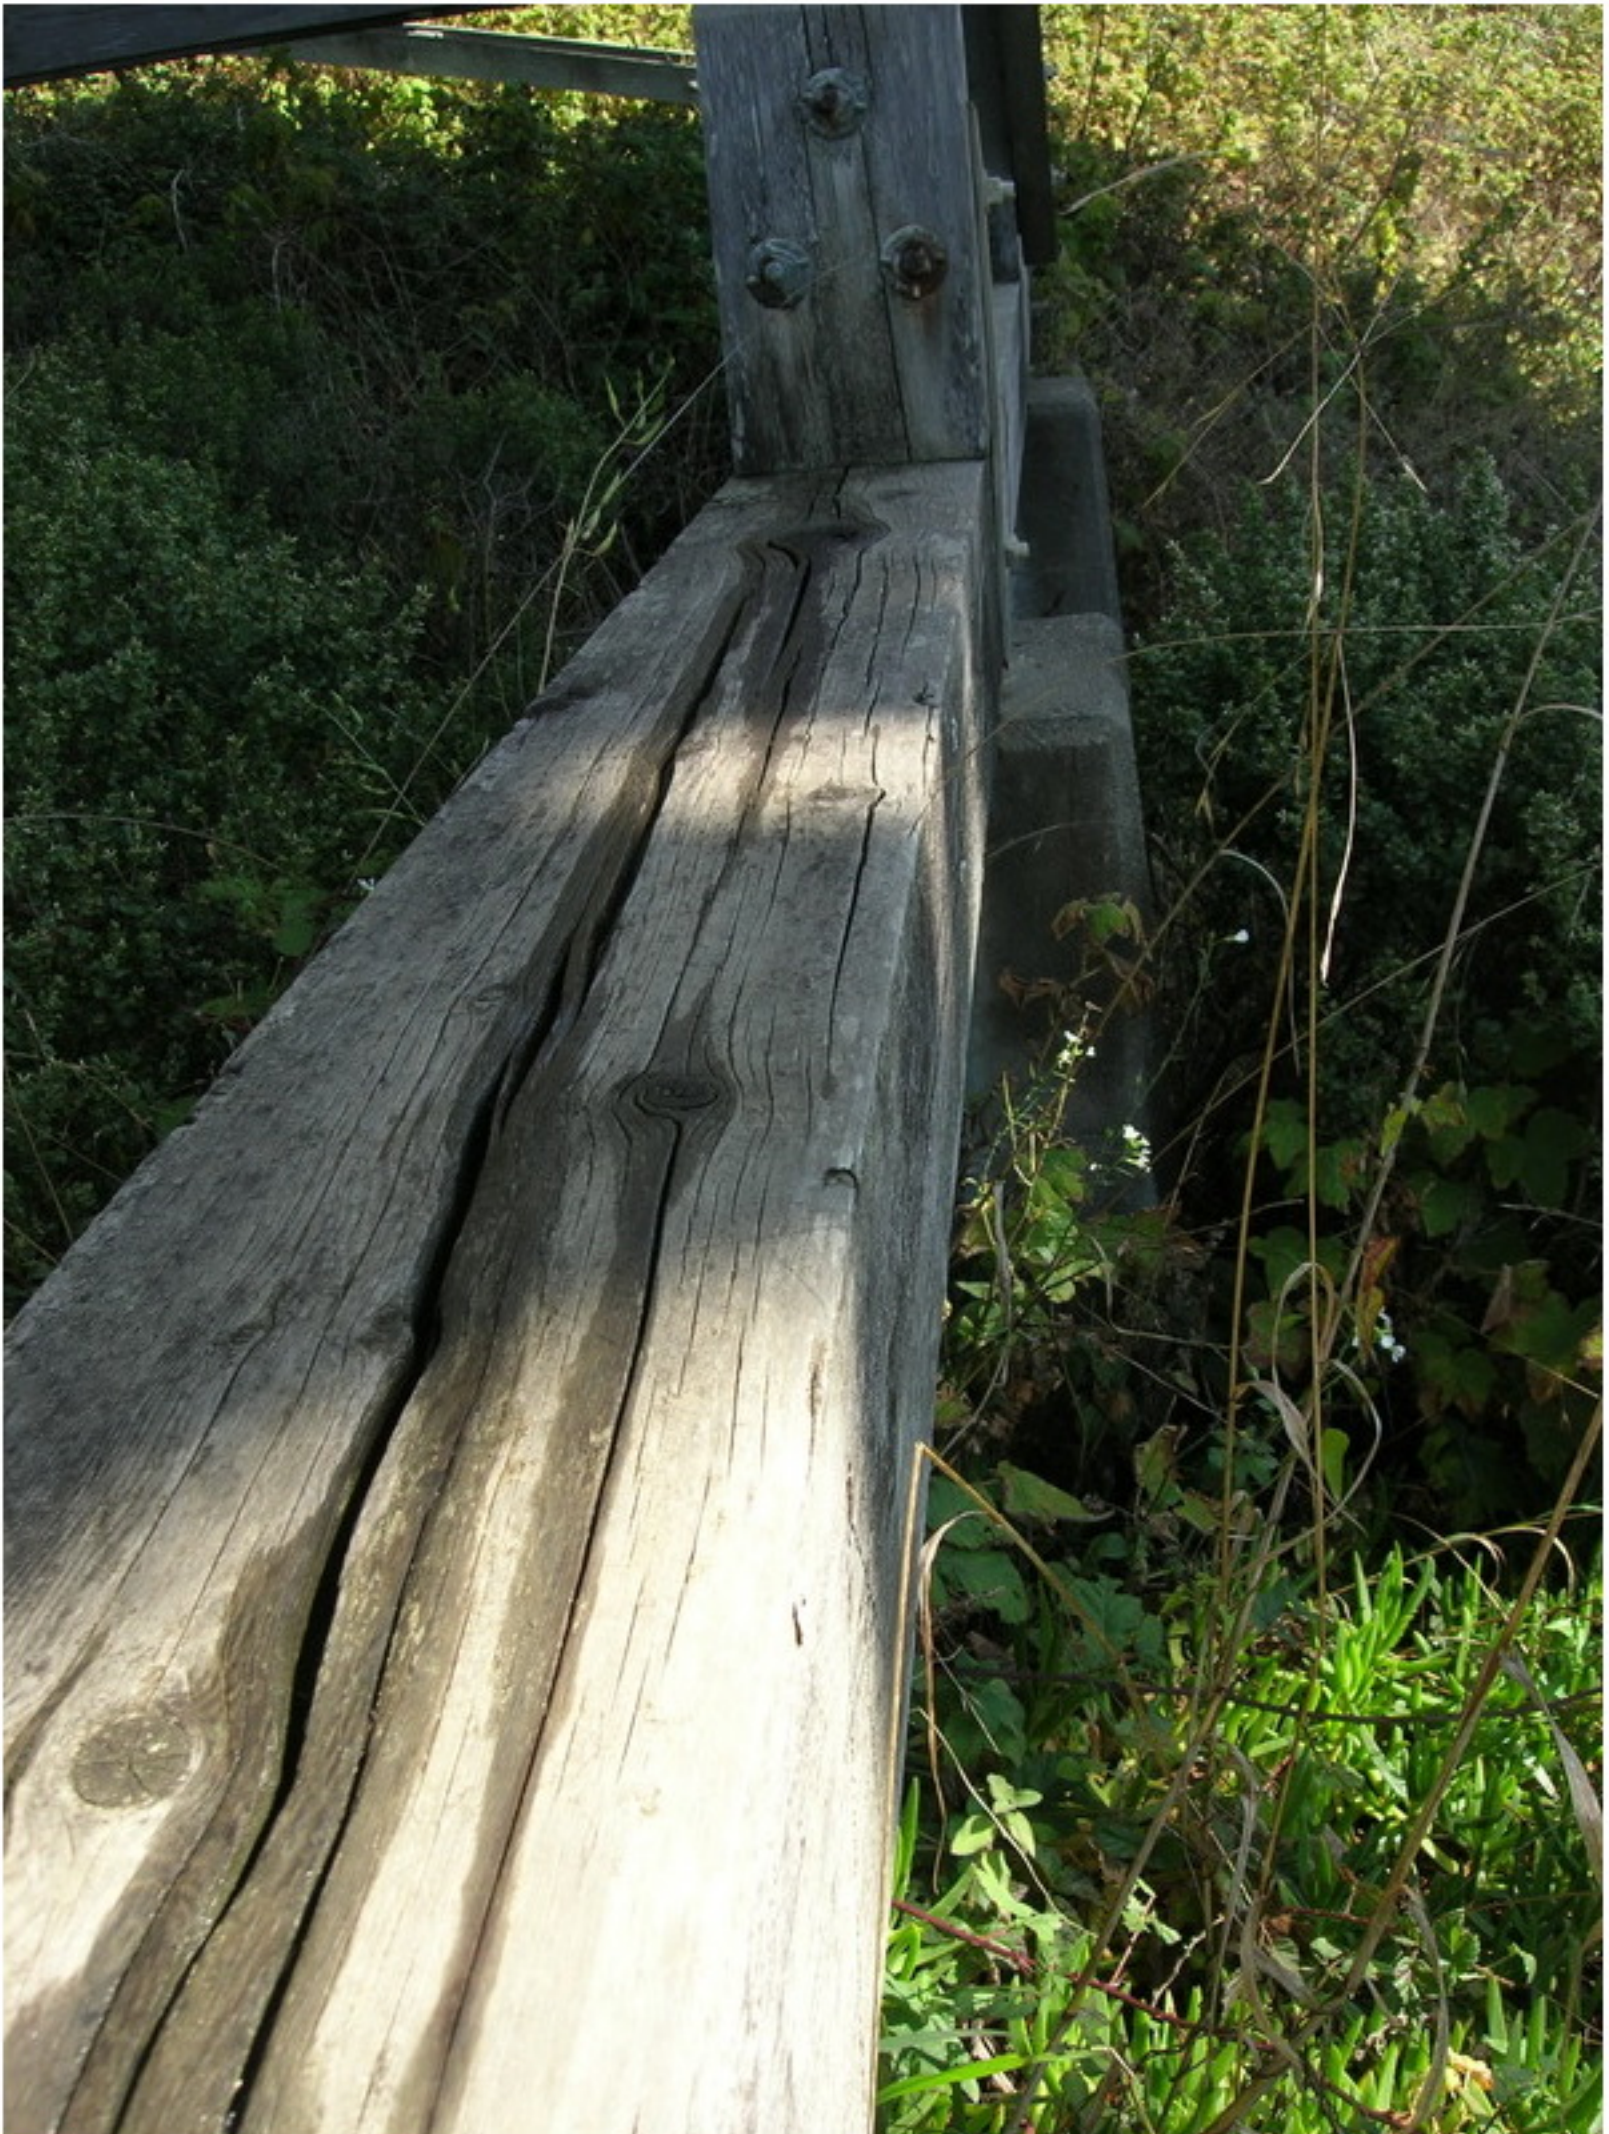
The horizontal transverse beam at the base of the legs of Bent 29 has 0.16 to 0.32 inch wide cracks in its top between Post/Leg 1 and Post/Leg 2, and between Post/Leg 2 and Post/Leg 3. The wood around the cracks/splits is damp and the interior appears to be soft then poked with a knife or awl. See photos No. 19 & 20, dated 10/06/2011, in BIRIS.

Photo No. 19
Looking east at the base of Bent 29 - Note damp splits in top of the horizontal member

Looking east at the base of Bent 29 - Note damp splits in top of the horizontal member
